# Mine Shift: The Williamson Diamond Mine In Tanzania.

EXAMINING GROUND DISPLACEMENT IMPACT ON MINES AROUND THE WORLD.

# The event

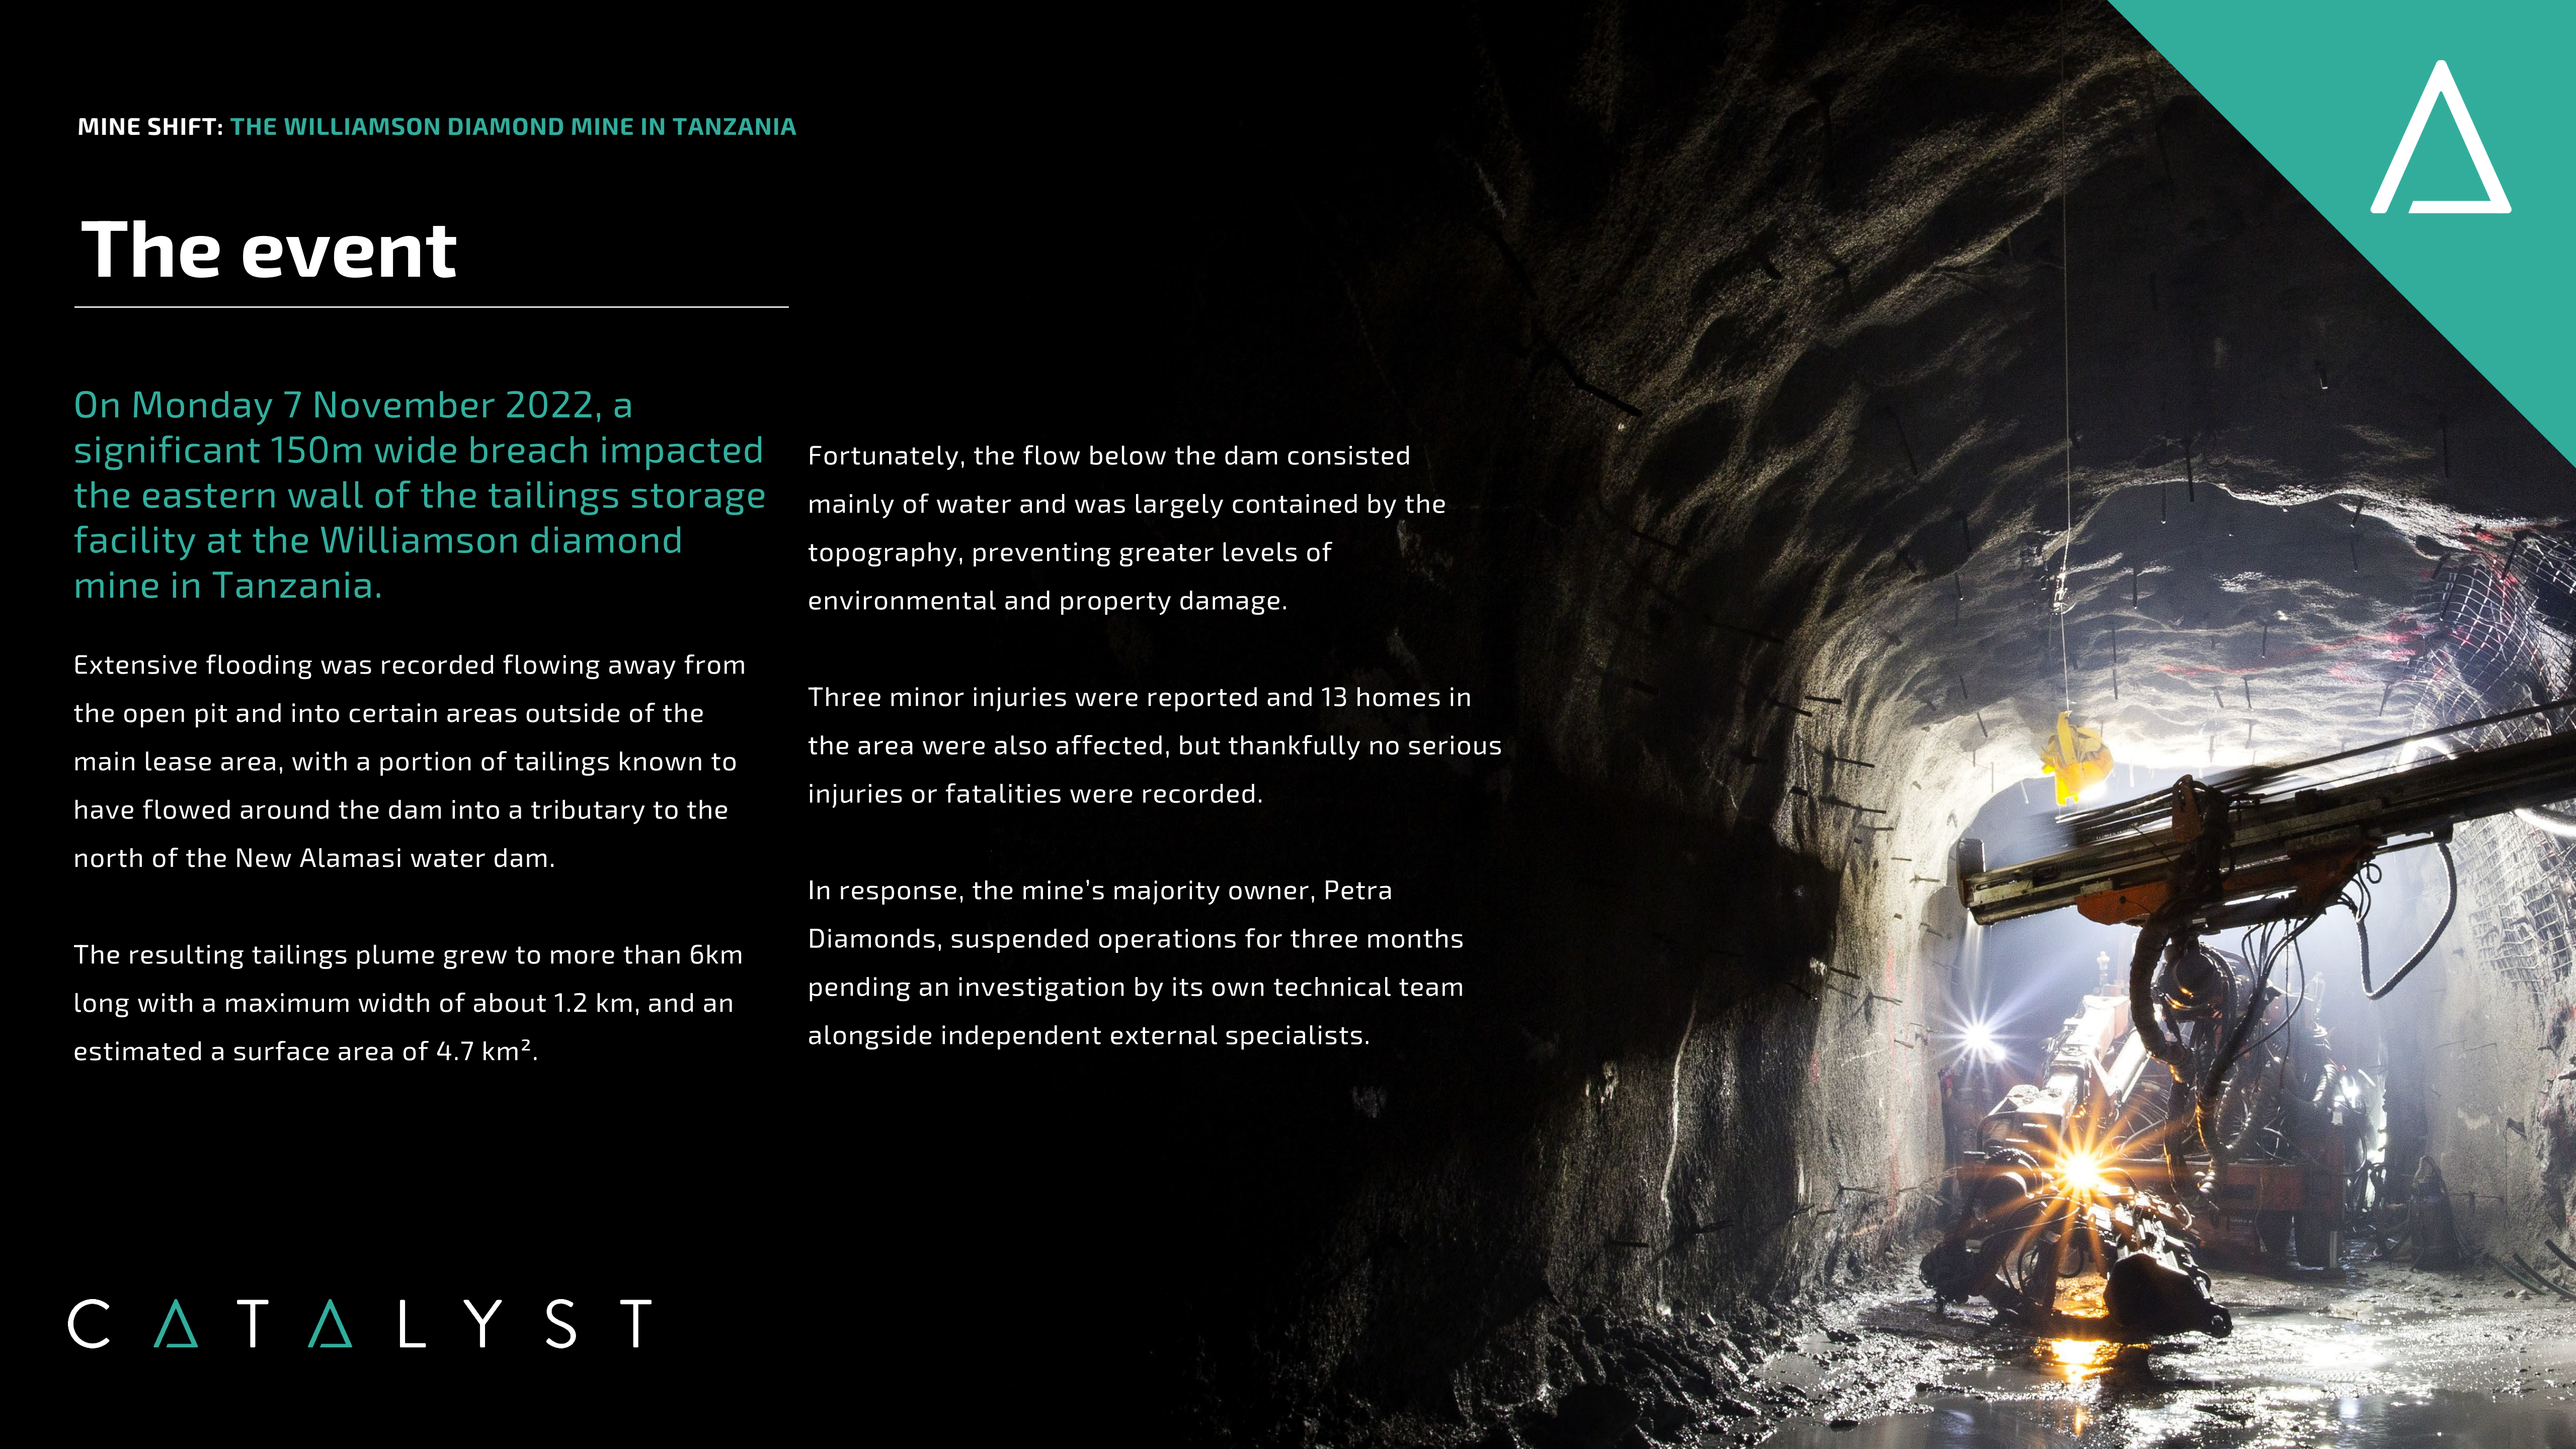
It appears that some of the original tailings wall material, including intact blocks, have been deposited on the downstream edge of the breach, especially on the south side.

There appears to be a step in the tailings at the site of the breach, suggesting a lower layer of denser tailings. This indicates that further releases could occur in rainfall.

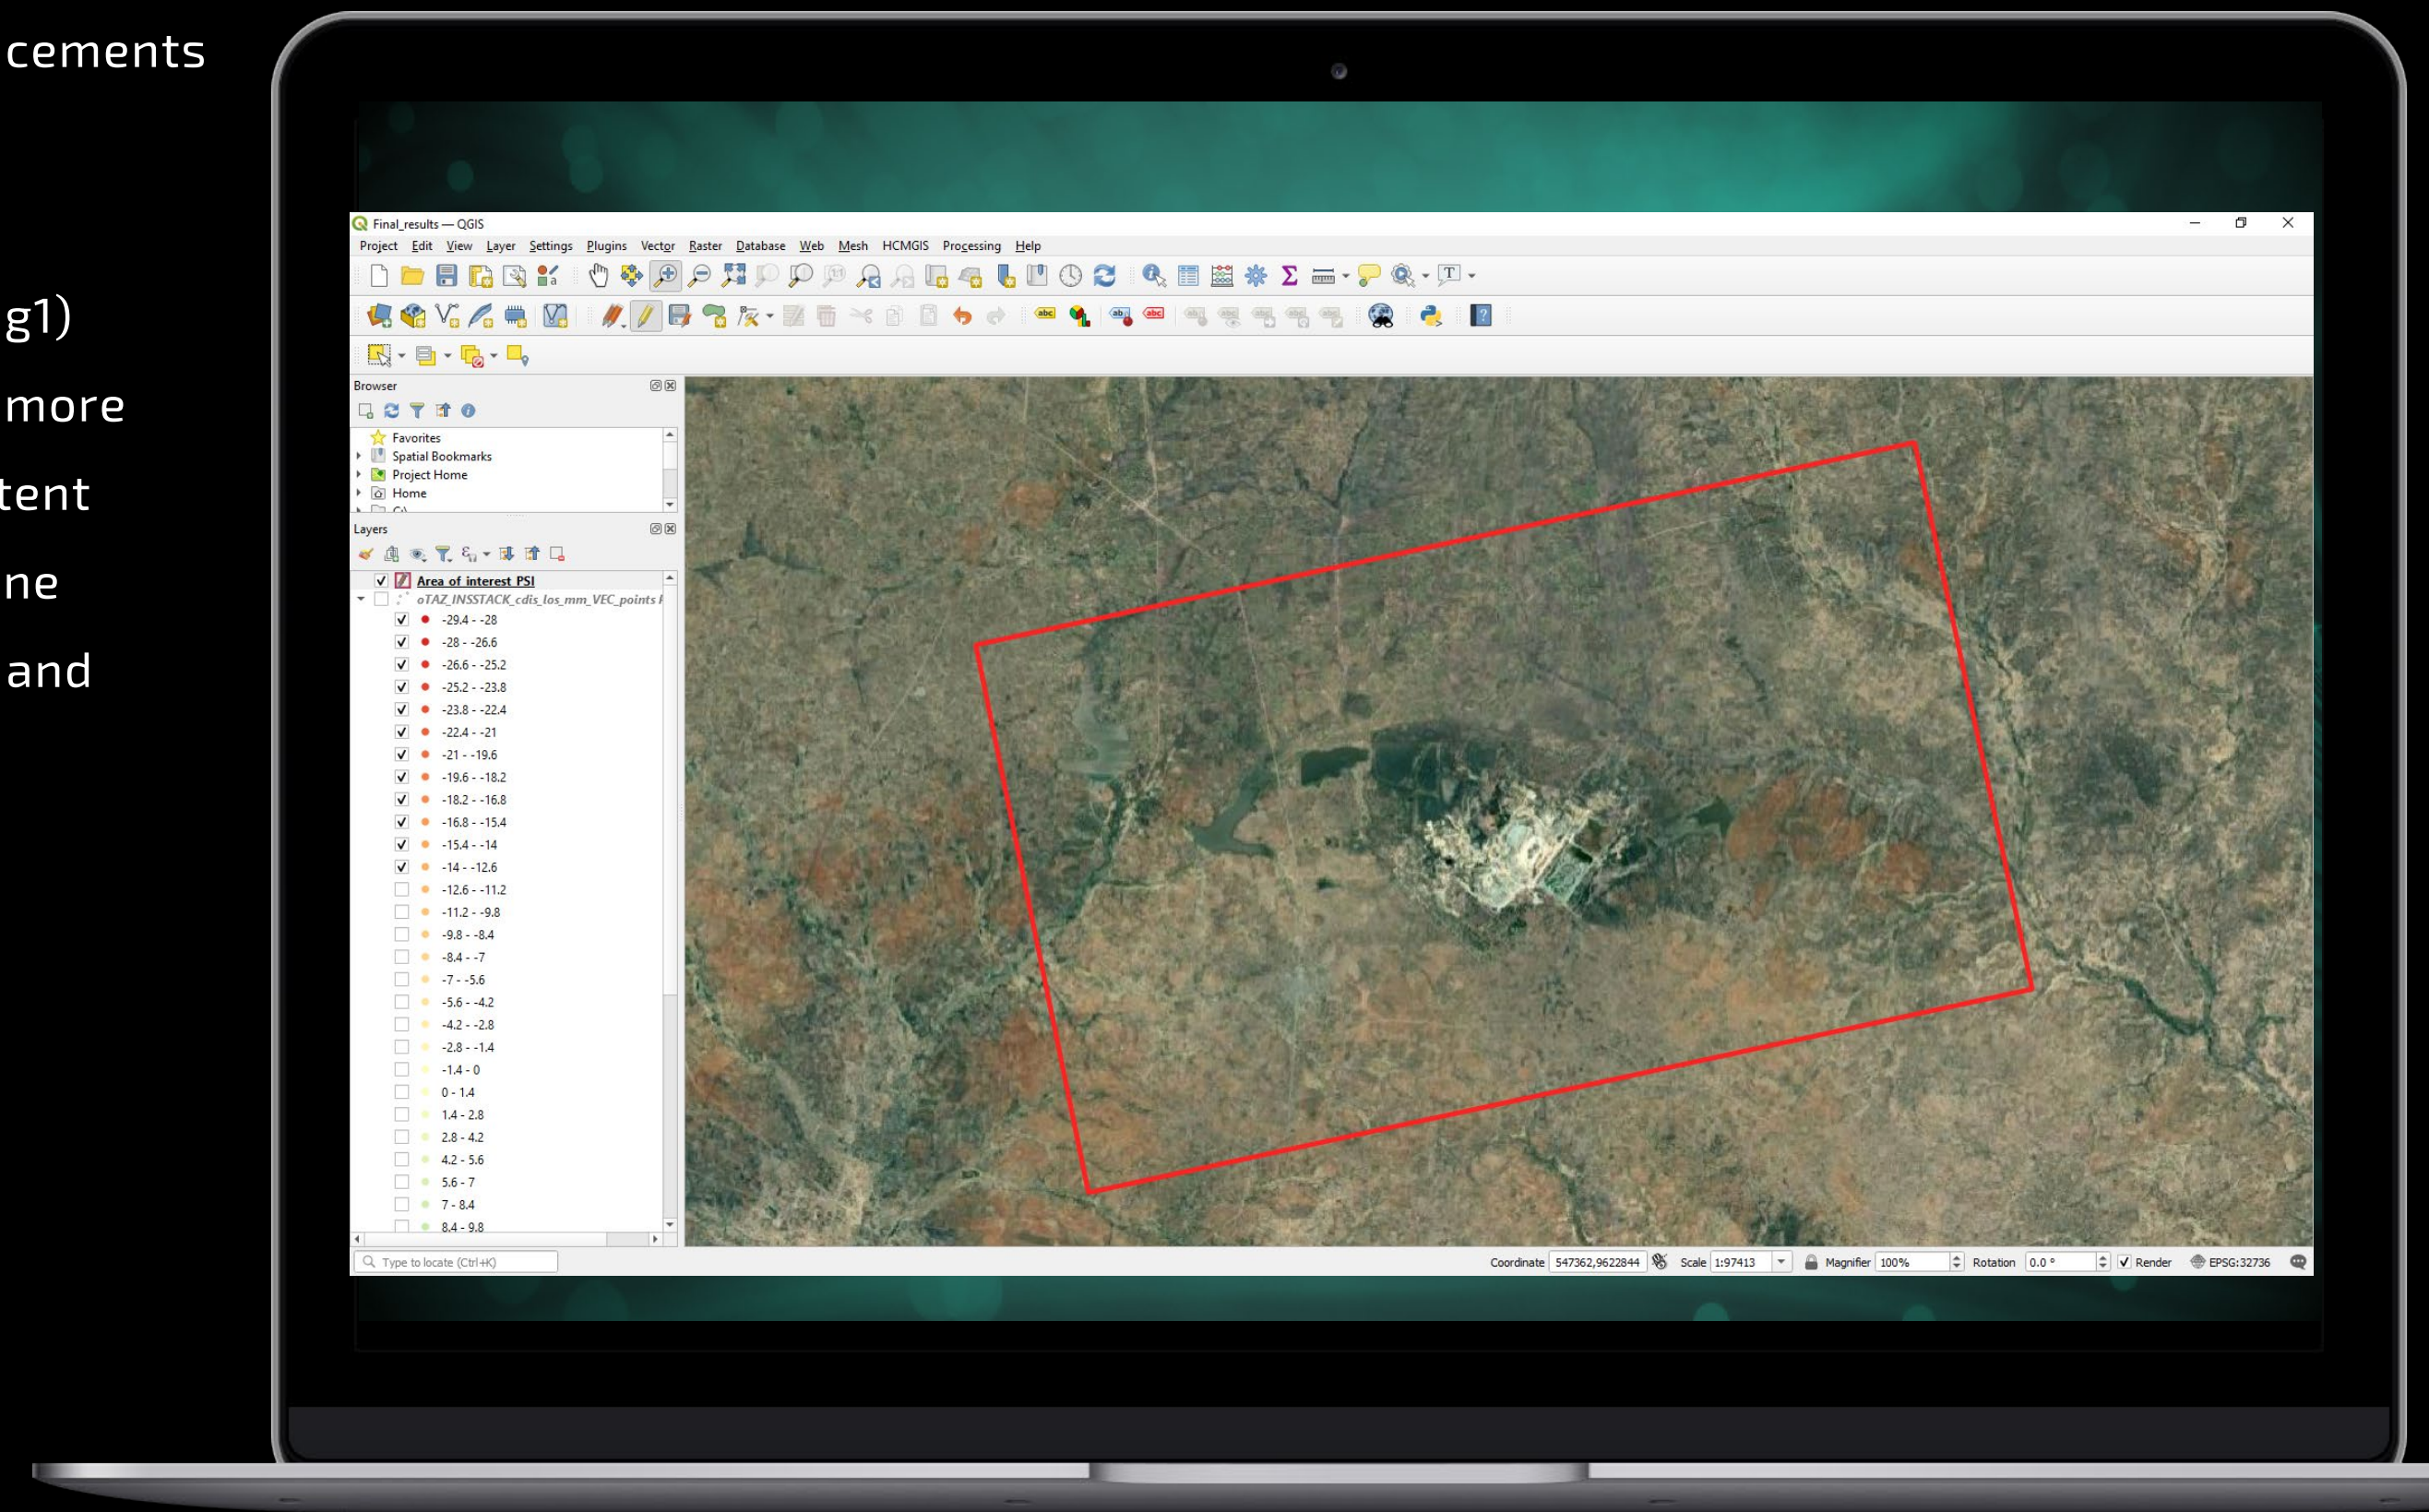
The process started with mapping (fig1) the entire area. This involved taking more than 840,000 measurements (persistent scatterers) across the Williamson mine to track ground displacement, speed and cumulative displacements.

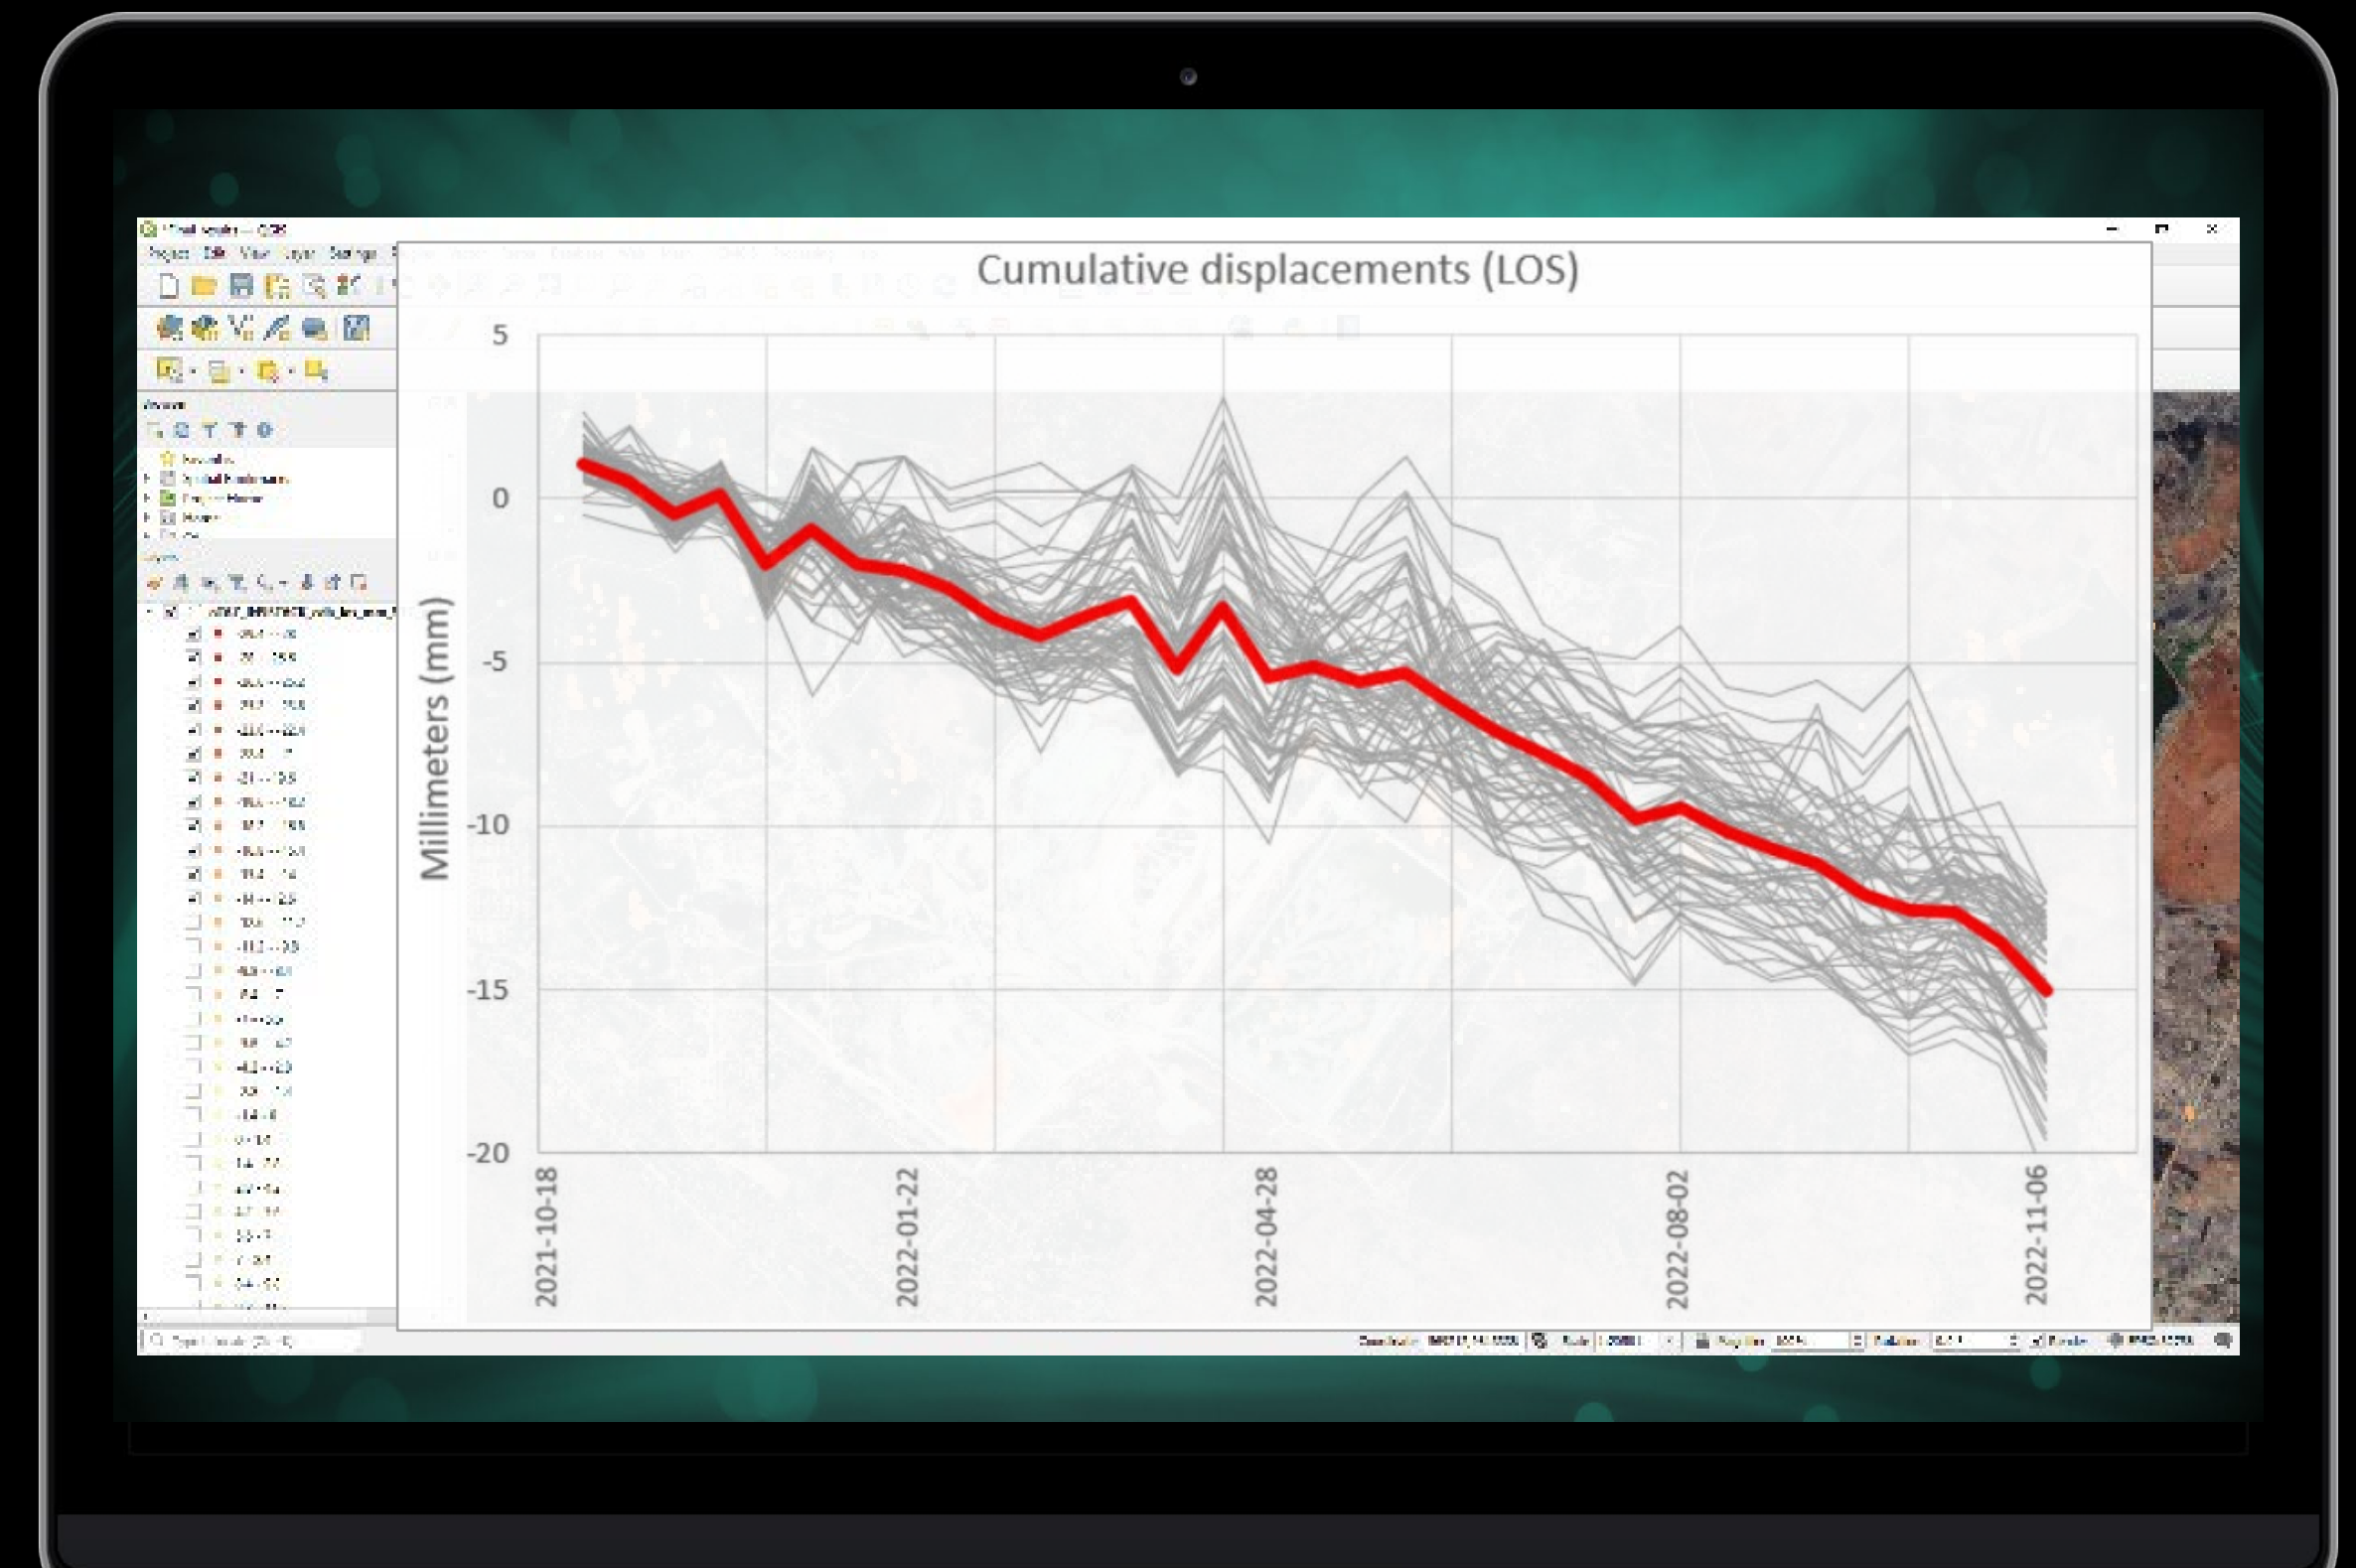
Once complete, we had identified a ground displacement range evident across the mine of -29.419mm to +34.039mm.

A considerable volume of measurements were recorded within a normal range of -12.6mm to 12.6mm and could be considered non-critical.

However, a small but very significant set showed high level of displacements at >12.6mm (0.085%) and >-12.6mm (0.49%).

When viewed in isolation - after removing the non-significant cumulative displacement points - you can see how the density and spatial clustering of critical displacement measurements (>12.6mm) are situated to where the breach occurred.

Through our analysis, we were able to determine that the ground displacement data uncovered spatial and temporal patterns that could have been used as early warning signs where closer monitoring would have been warranted.
