MINE SHIFT: EXAMINING GROUND DISPLACEMENT IMPACT ON MINES AROUND THE WORLD

The Collapse of the Jagersfontein Diamond Mine Tailings Pond.

The Jagersfontein Dam

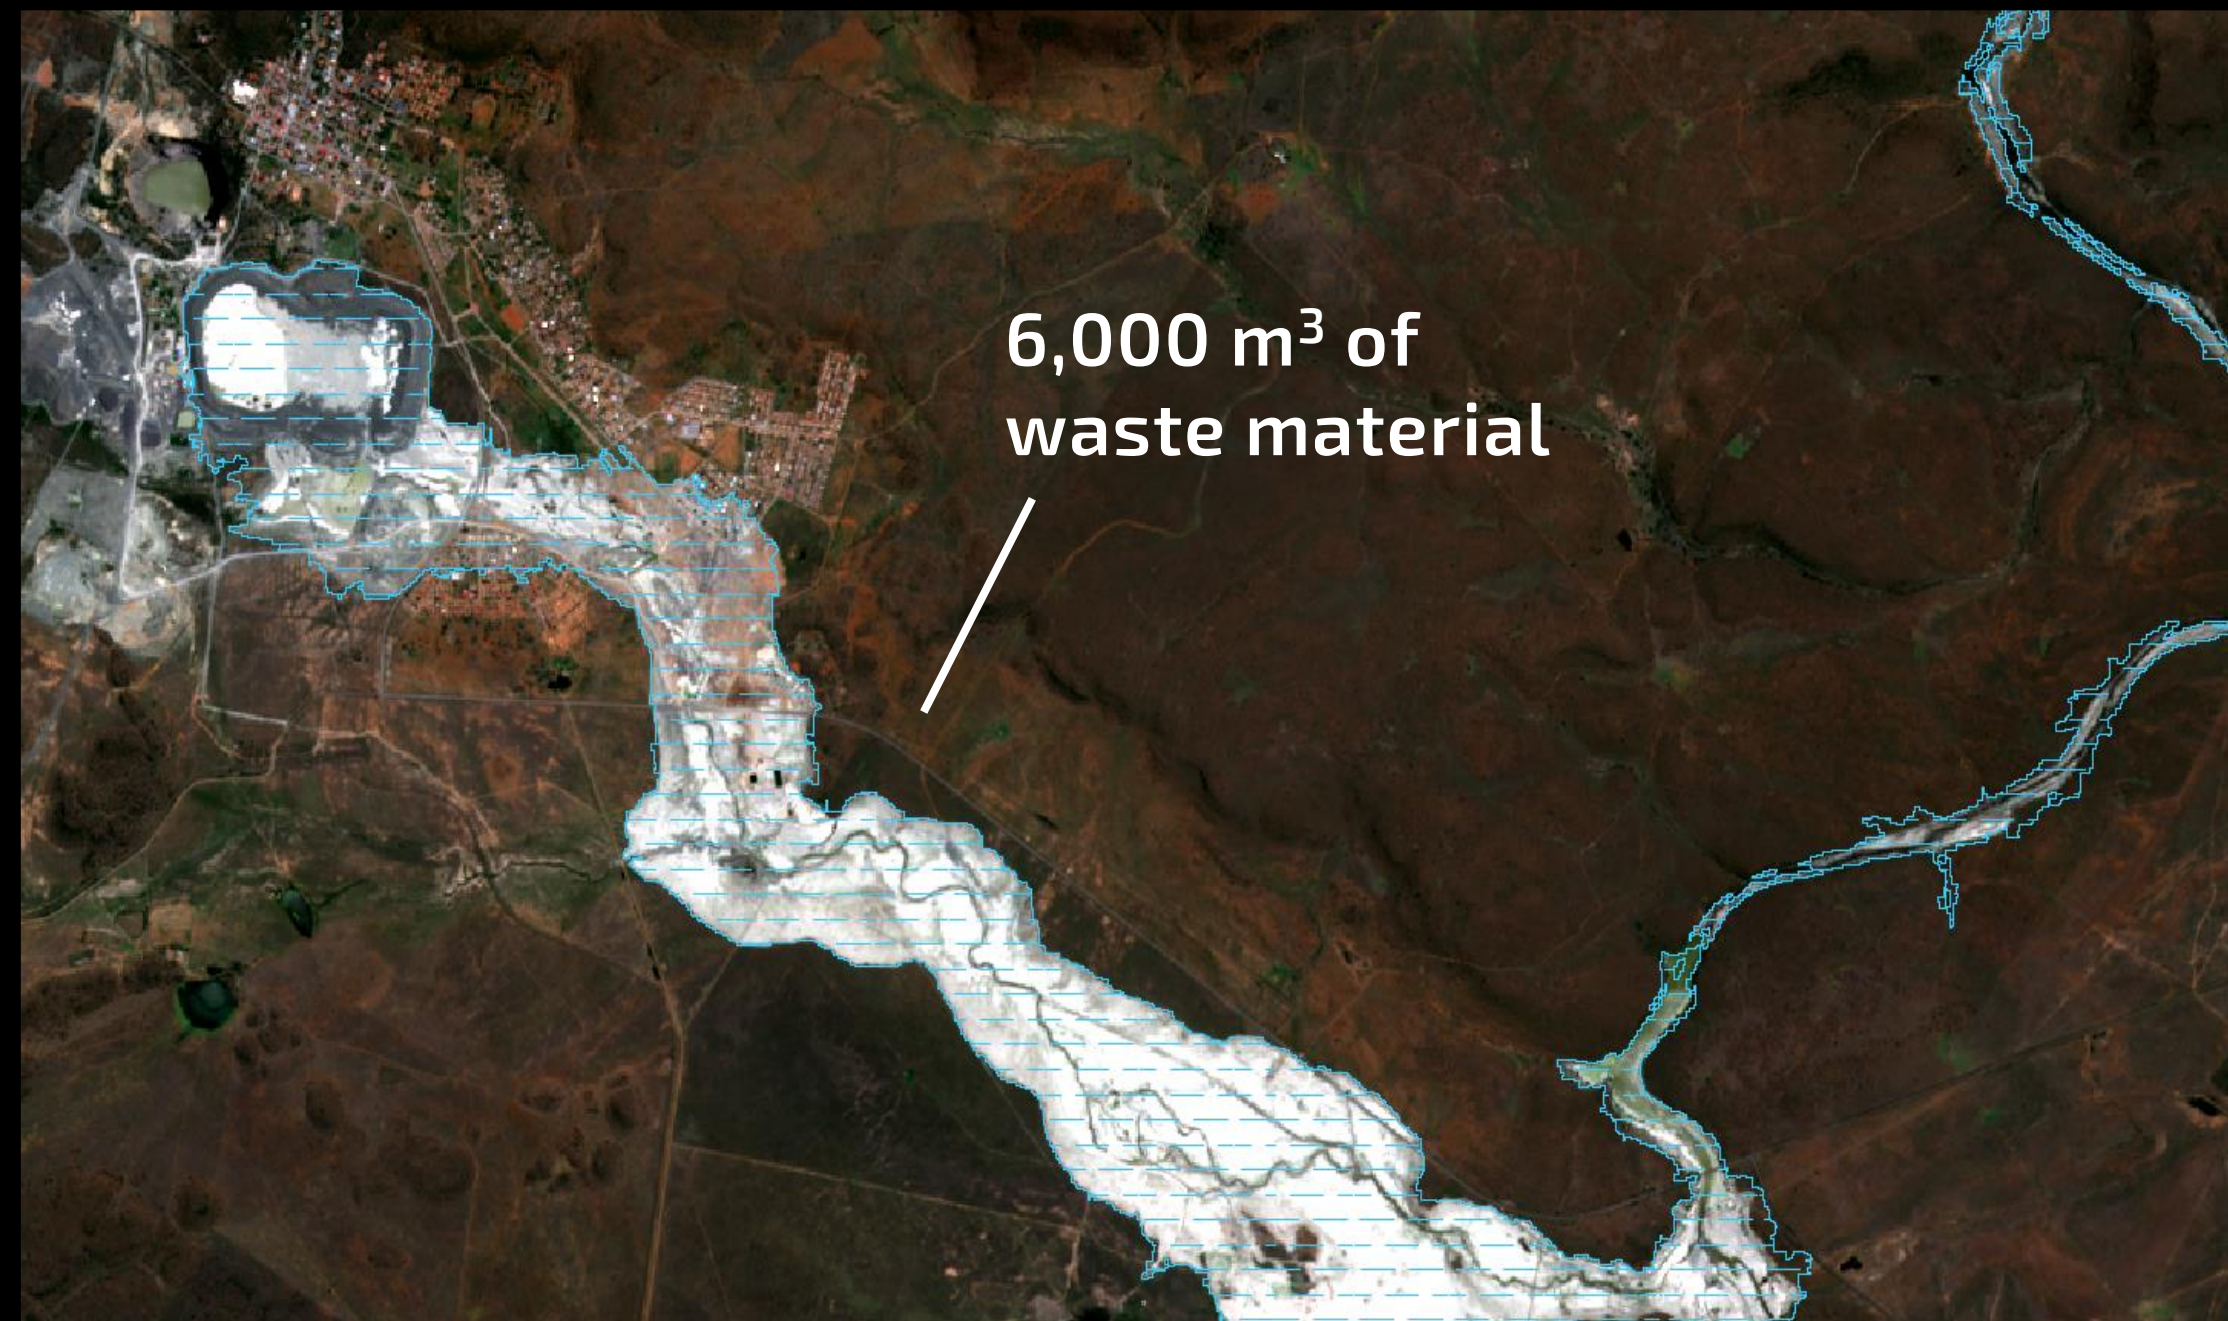
What's more, when the breach did occur the tailings flow surged through the residential areas and into the same flood risk areas CATALYST analysis had identified. (Fig.5)

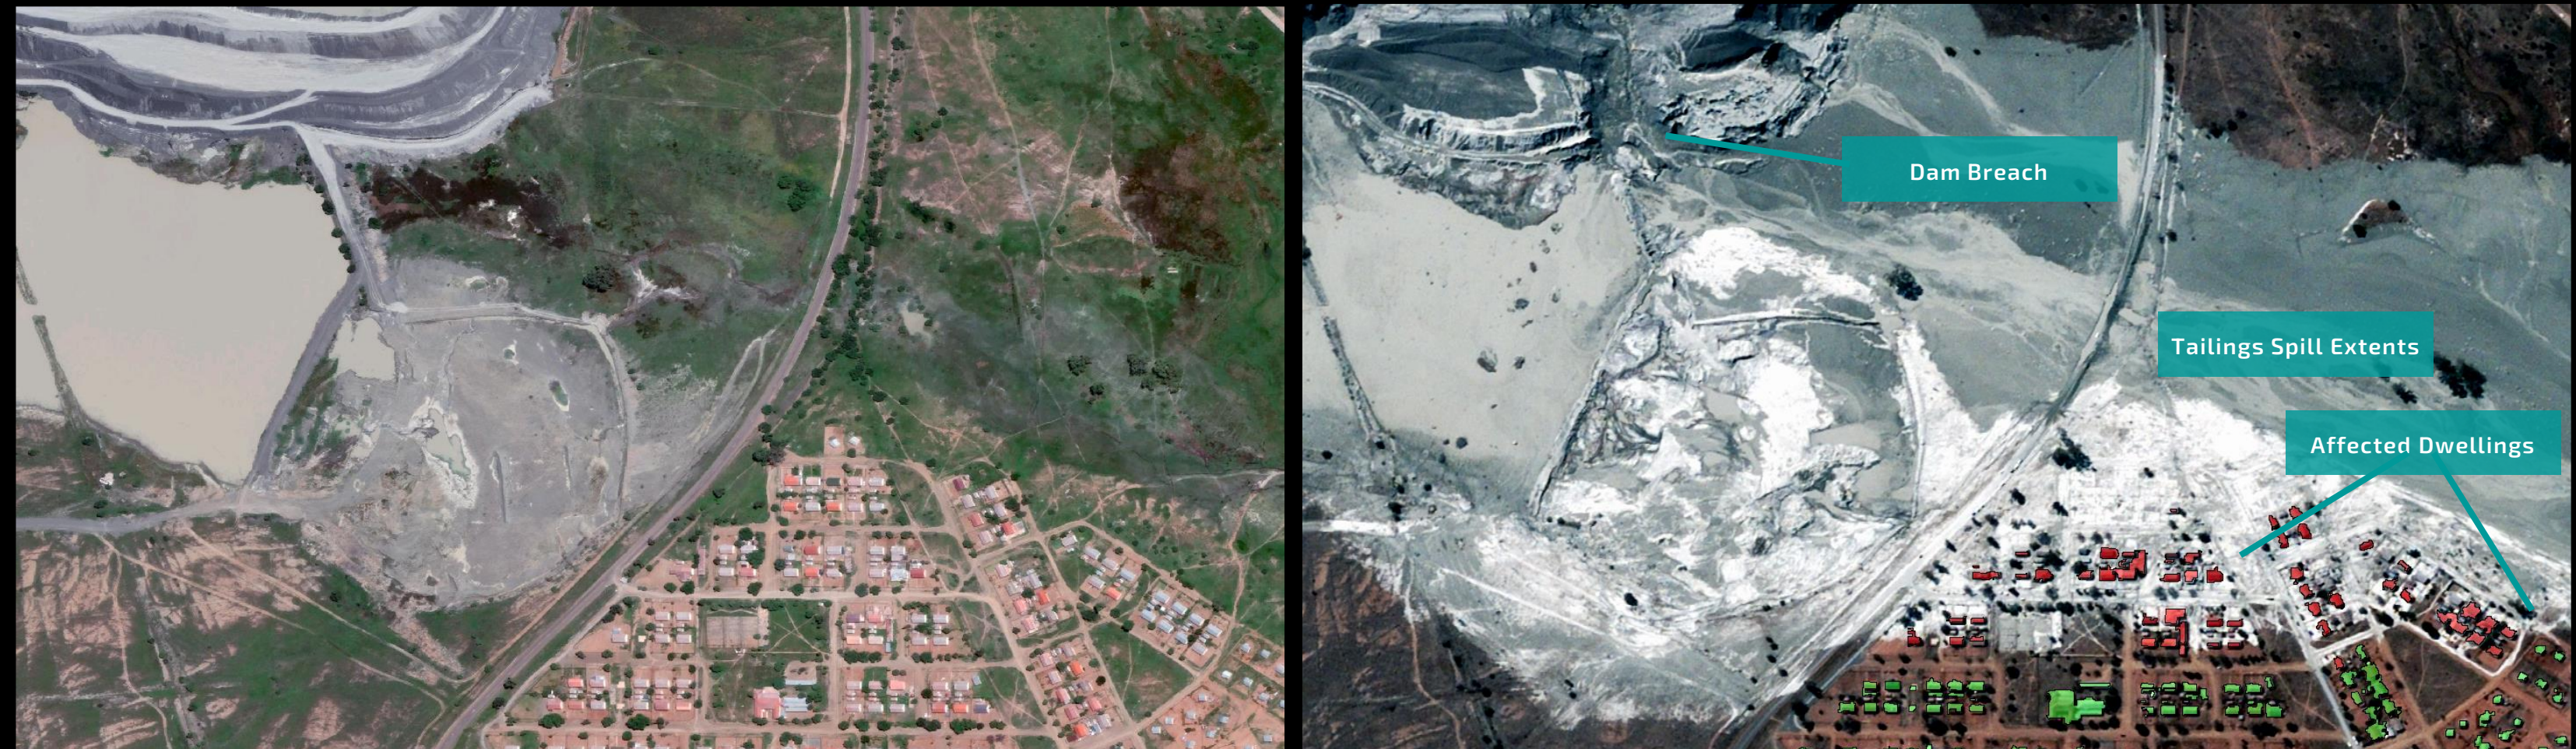
Fig. 6

Using intersection analysis between building footprints and the flood extents, our teams could still clearly identify the impacted buildings through the spill extents. (Fig.6)
