MINE SHIFT: [Examining Ground Displacement Impact On Mines Around The World](#)

The Warning Signs At The Cadia Tailings Dam

The Cadia Story

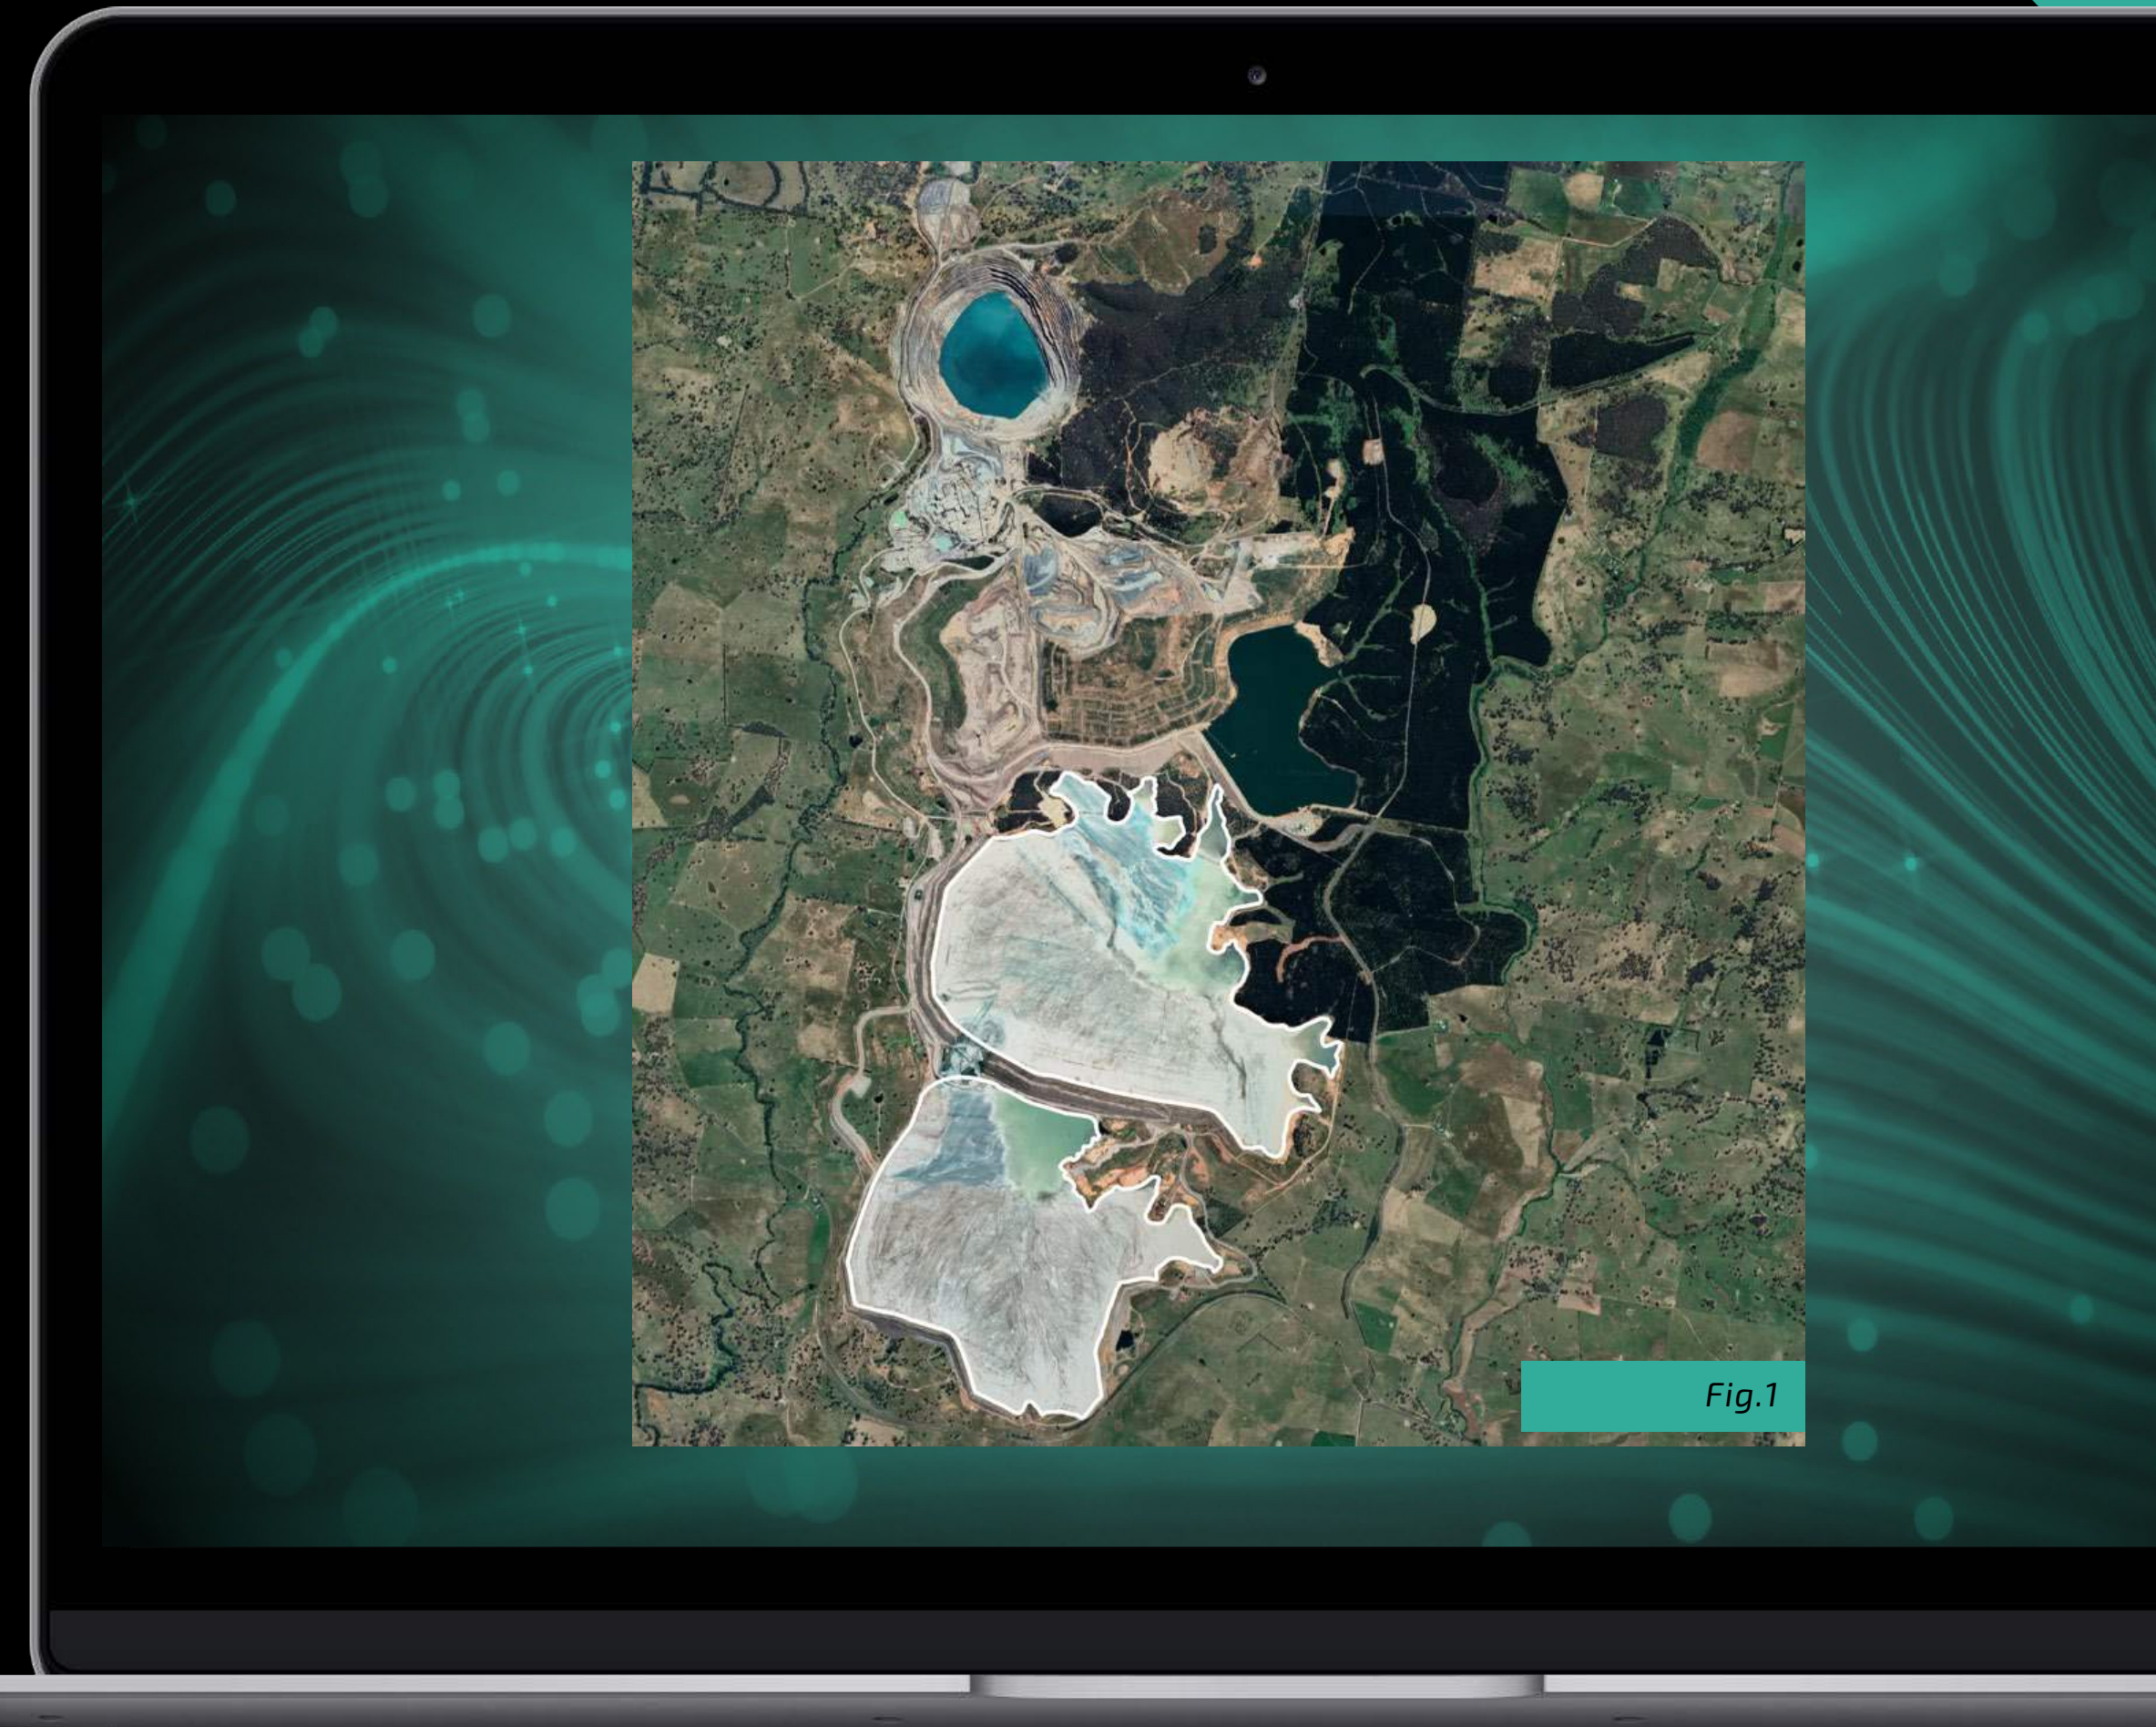
Late on Friday 9 March 2018, a portion of the wall connecting two tailings storage areas at the Cadia gold mine 'slumped'.

A year later, it concluded "the dominant factor [...] was the existence of a low-density foundation layer in the vicinity of the slump,"⁴ which had not been identified.

It also highlighted the "local height of the dam, prevailing phreatic conditions, and excavation at the toe of the structure in the area of the slump"⁴, meant the weaker structural integrity of the wall couldn't handle the pressure, resulting in the collapse.

This deformation triggered liquefaction of part of the tailings, causing it to slump forward and spill into the second dam.

The site was secured, and a comprehensive geotechnical monitoring system was introduced before an Independent Technical Review Board were appointed to conduct a full review.

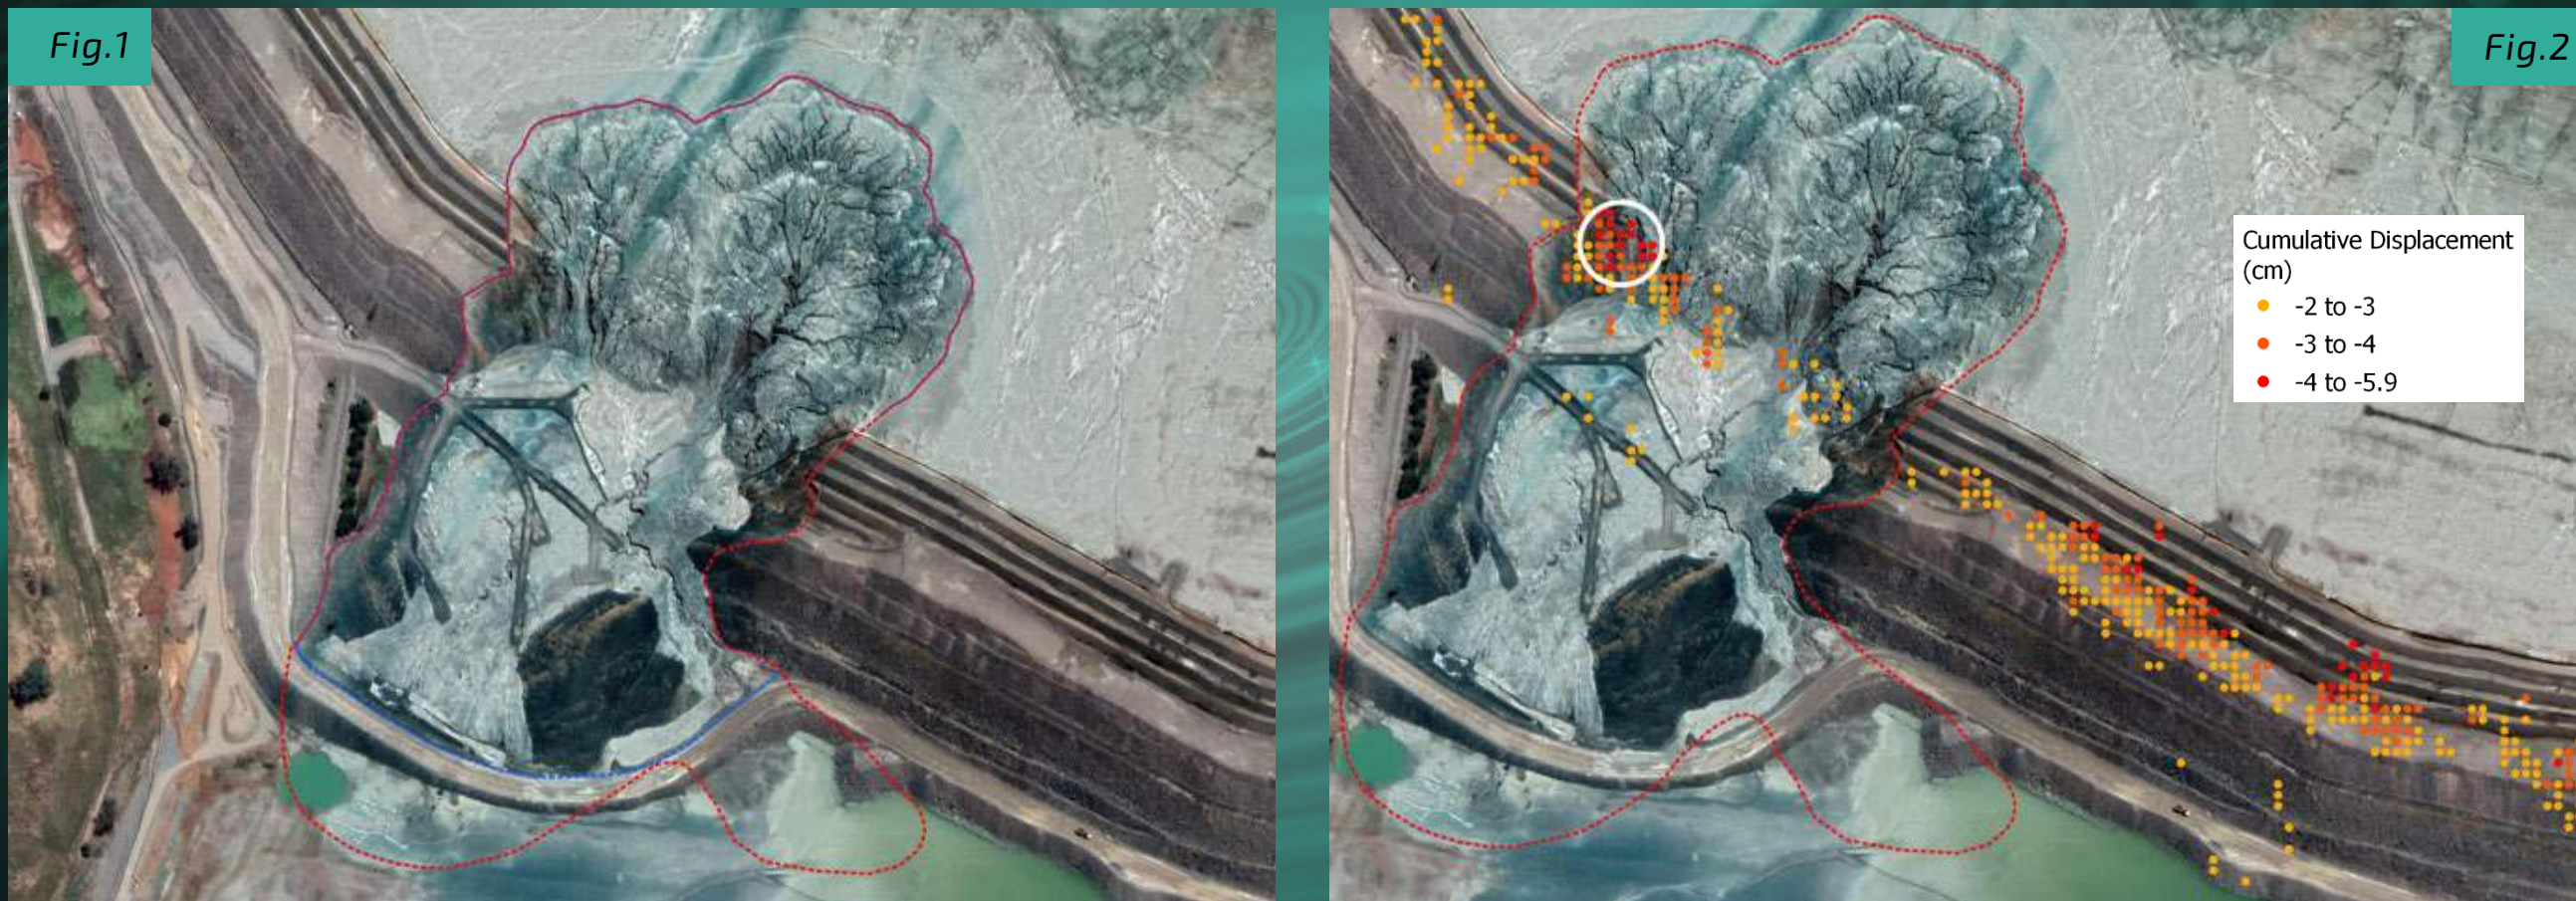
Combining satellite imagery of the breach with historical InSAR analysis, our team identified several areas of negative ground displacement spanning the length of the wall at the point of failure.

As you can see in Fig.2, multiple points of movement downward of -3cm to -5.9cm displacement occurred on the western point of the breach, suggesting this was the critical area of weakness in that part of the wall.

There are evident weaknesses in other areas of the wall (Fig.5), with higher density pockets of negative displacement points clearly visible either side of the breach.

In events such as these, having this visibility means maintenance teams charged with securing the site are more informed to not only the breach site but the status of the other potential at-risk areas.

Equipped with this data, they are safer, more effective, and more prepared to carry out their planned or emergency repairs.

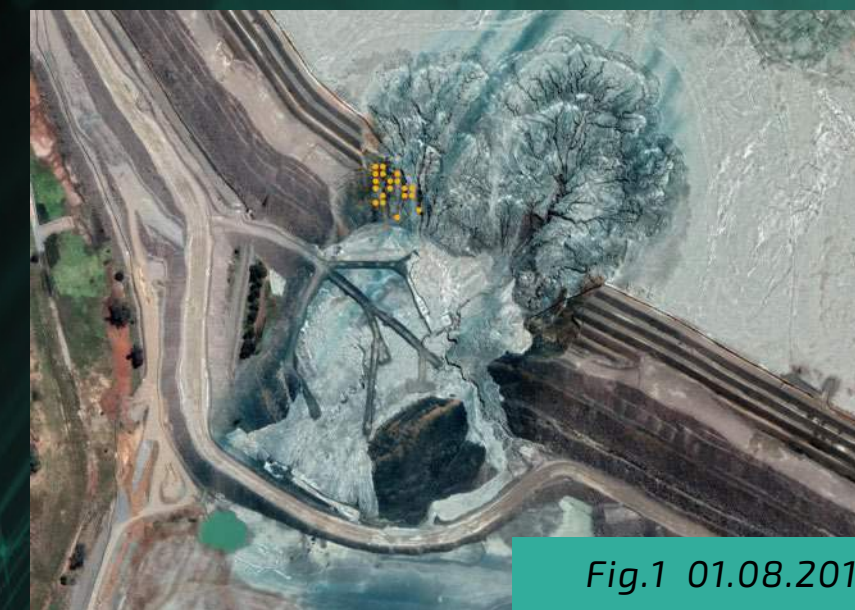
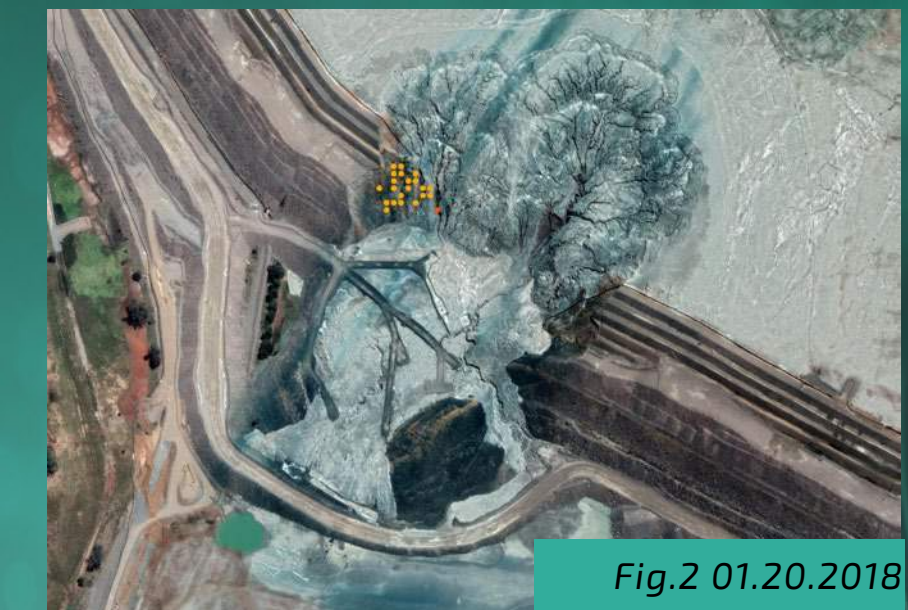
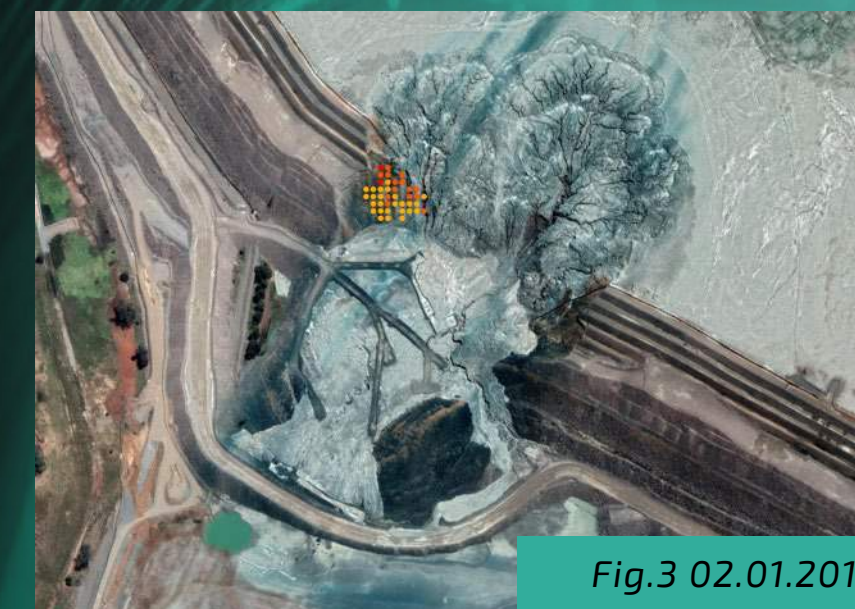
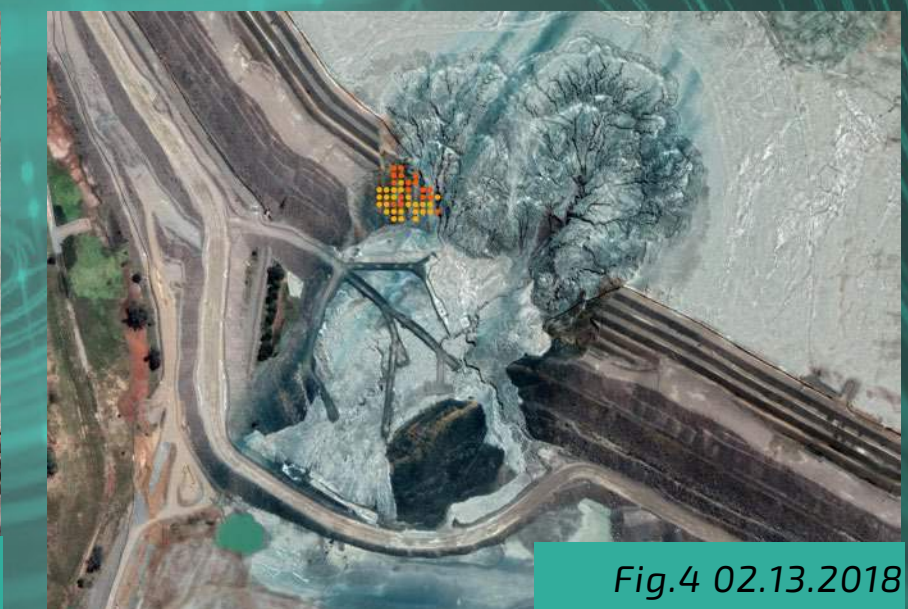
In our analysis, we identified signs more than two months before. On 8 January 2018 (Fig.1), a cluster of negative displacement points of -2cm to -3cm were detectable at that critical point of weakness in the wall. Twelve days later (Fig.2), there's an increase in both volume and speed of movement with -3cm to -4cm displacement beginning to emerge.

The trend continues at the start of February (Fig.3) with a spread of accelerated movement and by middle of the month (Fig.4) the magnitude of movement had increased to -4cm to -5.9cm.

This change in magnitude is notable in comparison to previous Mine Shift examples - where incremental displacement occurred over long periods of time – and underlines the role InSAR can play in augmenting routine physical inspection cycles.
